# Tornado Rating Document

**Weseke (Nordrhein-Westfalen)**

**25 MAY 2021**

**Intensity Rating: F1 / F1T3**

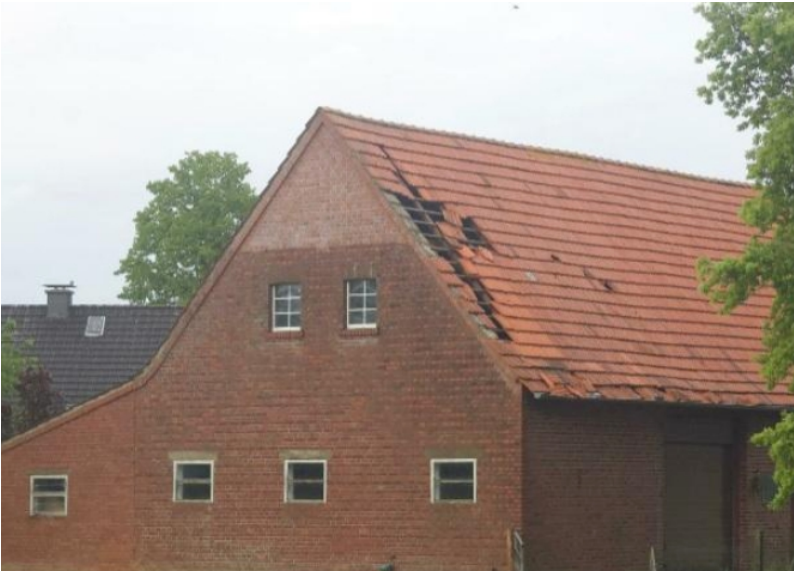
### **01 Building (51.9119N 6.8531E)**

Some ceramic slates blown away on the west side of the building. Ratio <20%.  
DI Roofs: DoD1 (isolated tiles <20%) results in IF0+ / F0T1.

**Result: F0T1**

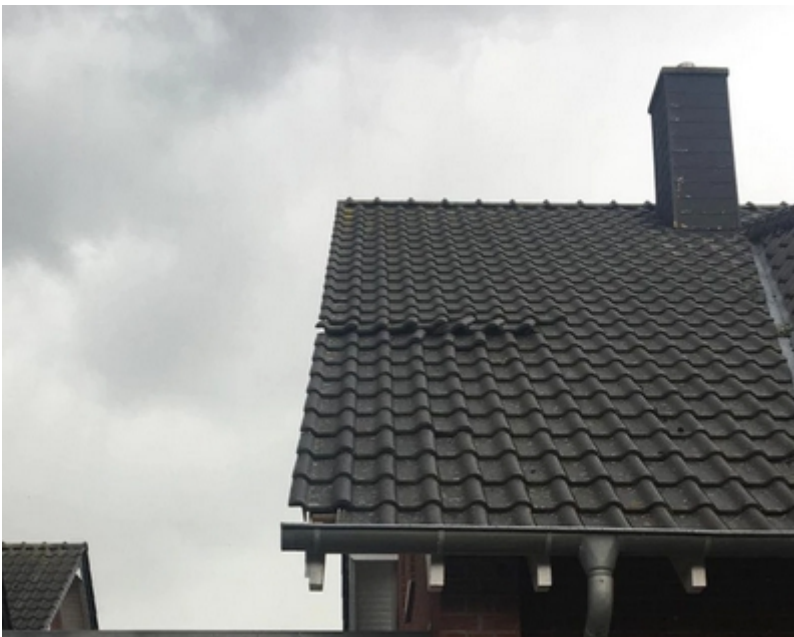
### **02 Residential Building (51.9121N 6.8547E)**

A single row of ceramic slates was lifted, but wind failed to blow it away.  
DI Roofs: not defined. If DoD1 with ratio of <20% results in IF0+, than damage at building 02 results in IF0 / F0. (Proposal for DoD0 needed)

**Result: F0**

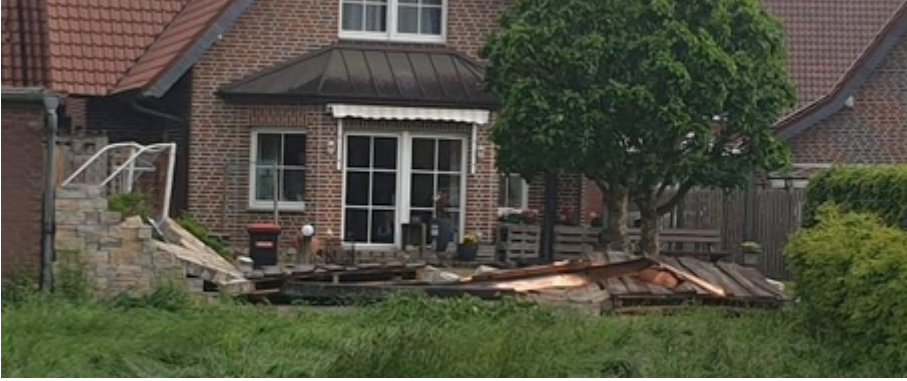
**03 Masonry Wall** (51.9120N 6.8576E)

Wall collapsed. Single row brick structure. Failure point unknown.  
DI MW: DoD1: Collapse: Not defined.  
Result: None

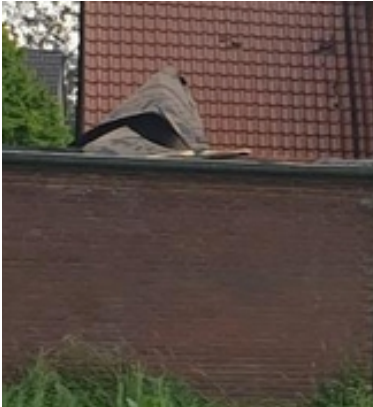
**04 Shed** (51.9119N 6.8575E)

Roof cover partly lifted, but not ripped-off and thrown. According to photo material, loss ratio may reached >20% at a rough estimate.

DI Roofs: DoD2: IF1

**Result: F1**

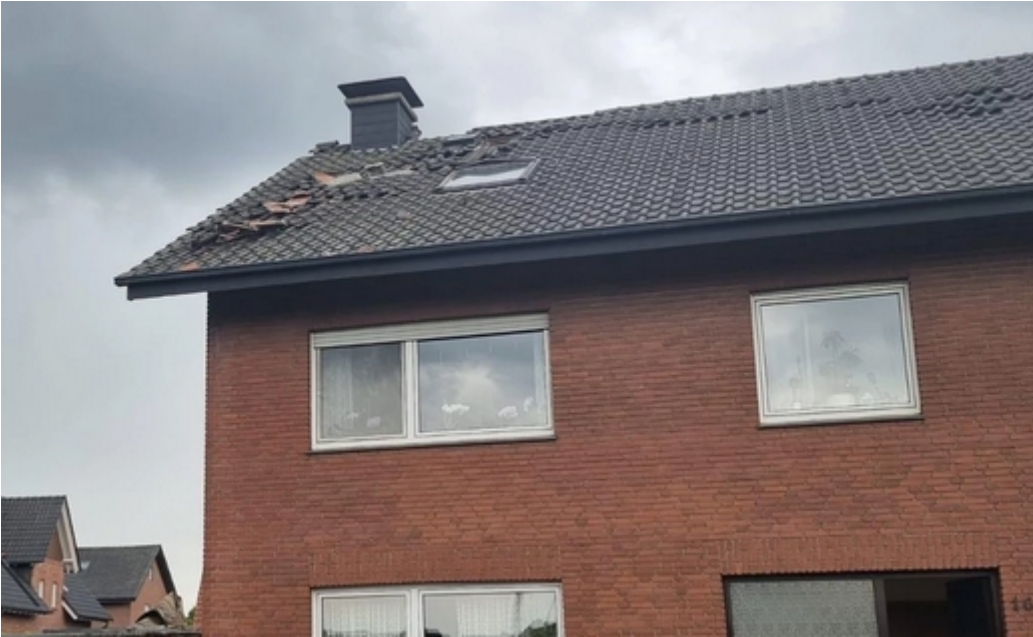
**05 Residential Building** (51.9119N 6.8579E)

Some single ceramik slates blown away and some others lifted, but not thrown. Loss ratio <20%. DI Roofs: DoD1: IF0+ / F0T1.

**Result: F0T1**

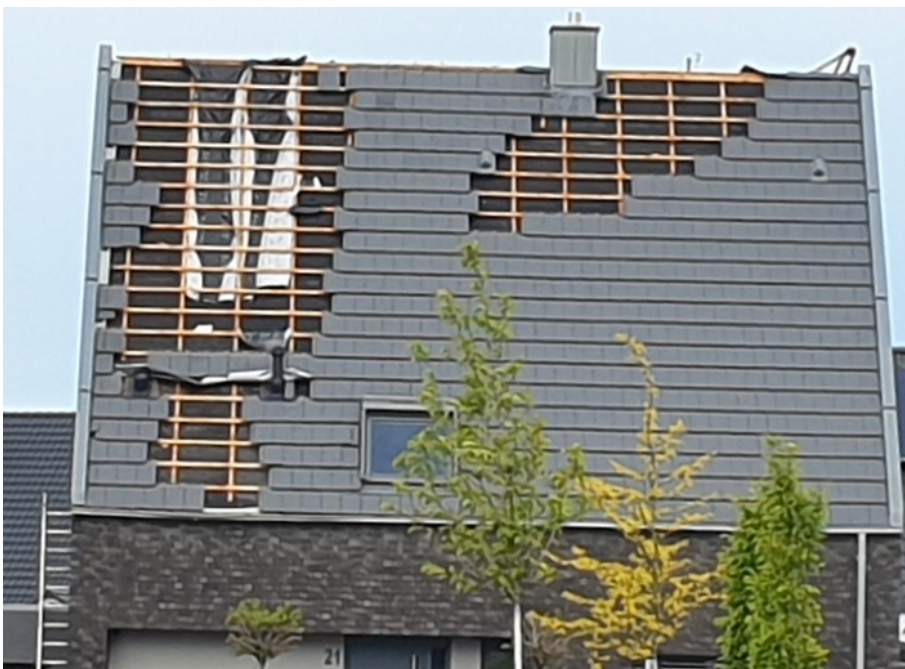
**06 Residential Building** (51.9119N 6.8628E)

Large parts of slates blown off on the west side of the building. Loss ratio 40-50%. DI Roofs: DoD2 (20-50%) results in IF1 / F1. It is not clear whether one can expect a high-end F1 rating here or not. Damage cannot be estimated with additional T-Scale.

**Result: F1**

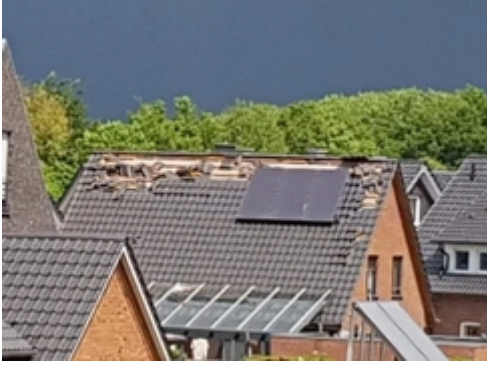
### 07 Residential Building (51.9118N 6.8631E)

Some parts of slates blown off on the west side of the building. Damage is limited to the upper section of the roof. Loss ratio about 20-25%.

DI Roofs: DoD2 (20-50%): IF1 / F1.

**Result: F1**

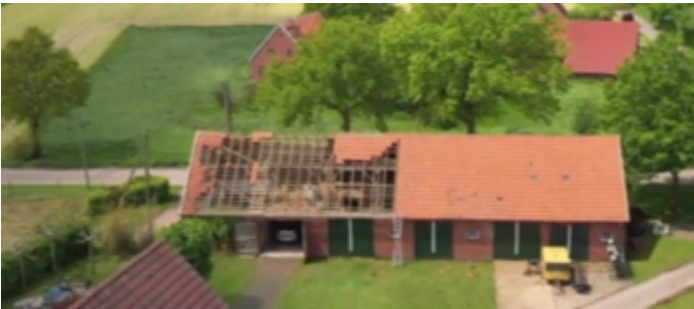
### 08 Barn (51.9118N 6.8775E)

Large parts of roof cover (ceramik slates) lifted. Loss ratio: 40%.

DI Roofs: DoD2 (20-50%): IF1

**Result: F1**

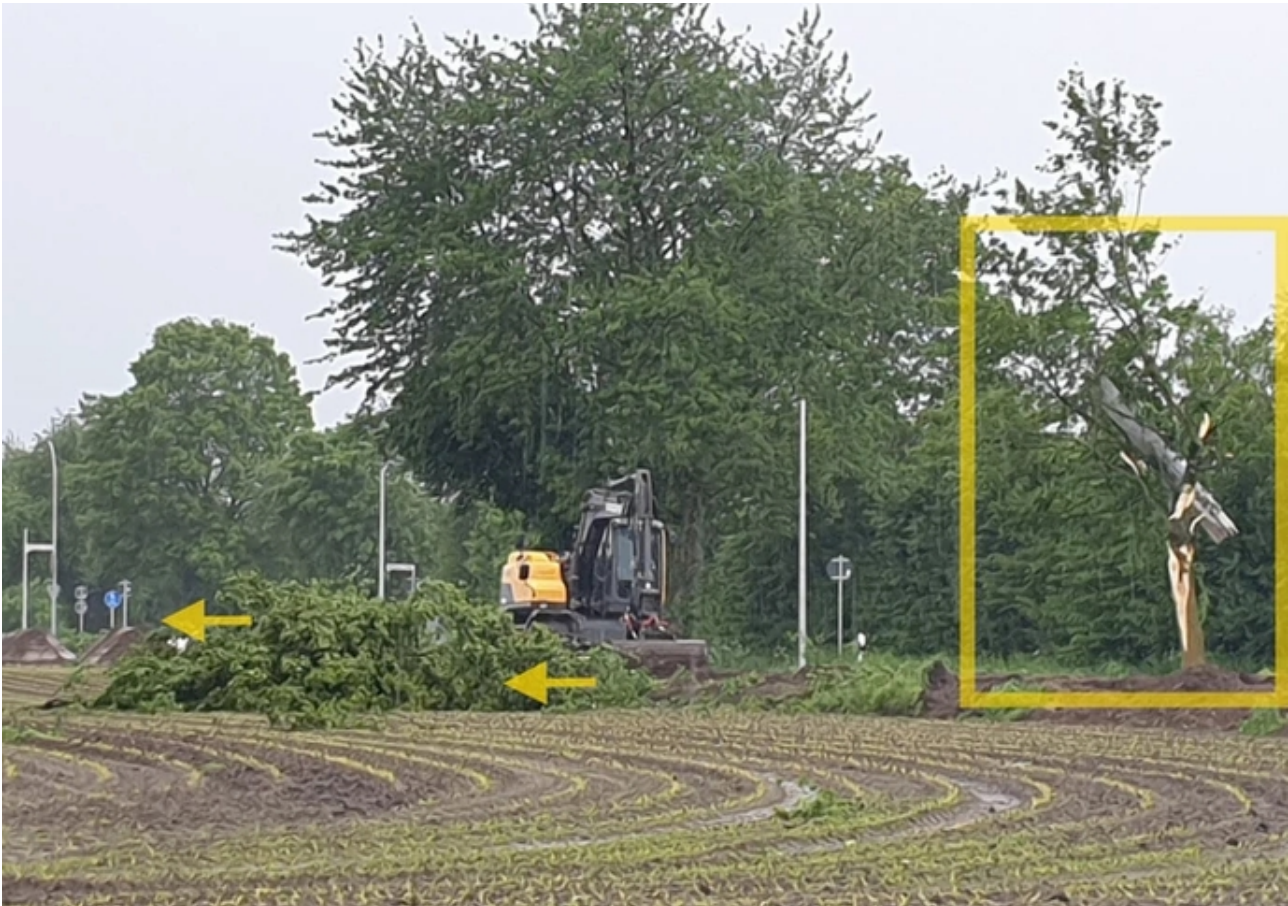
Trunk snapped, parts of large branched and tree crown snapped and thrown. The trunk itself was not thrown. Stability parameters unknown; using average parameters: DI 3 (Other Hardwood): DI Sub c : Upper F1.

**Result: F1T3**
